## Link Fractures in Eccentrically Braced Steel Frames

By Michel Bruneau, Ph.D., P. Eng.,  
Charles Clifton, Ph.D., FIPENZ,  
FNZSEE, Gregory MacRae, Ph.D.,  
P.E., Roberto Leon, P.E., Ph.D. and  
Alistair Fussell, B.E.(Hons), ME,  
MIPENZ, CP Eng.

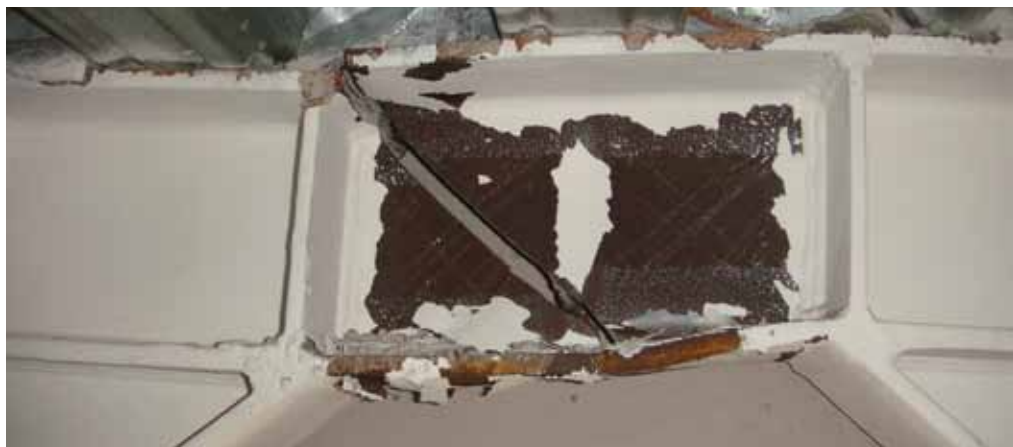
Figure 1: Fractured EBF in Pacific Tower. Courtesy of Sean Gardiner, CPG New Zealand Ltd.

could not be closed, suggesting greater residual deformations at that level. This level was the first in which a detailed evaluation was undertaken. One fractured EBF active link was discovered (Figure 1) at that level. The fracture propagated from one top corner across the active link region and resulted in significant residual deformation. Temporary strap cross-bracing was welded to the active link frame to provide lateral load resistance while a repair strategy was developed. The active links in the top 4 stories of this frame were subjected to higher inelastic demand than any other frame. These 4 links had a link length of only 400mm, half the link length of the other links in the building, accounting for the greater magnitude of inelastic demand. The 4 links are being replaced. This replacement will comprise cutting out the active link and a proportion of the collector beam and brace, and site welding new components back in. This method has been used successfully in the second building with fractured links (Figure 2), which is now repaired and back in service. The welding sequence was developed to minimize locked-in residual stresses. The replacement of this fractured link and the three links below are being undertaken in March 2012, and are the only repairs required to the structural system. This type of failure has not been reported in either EBFs tested in the laboratory or from damage reports from other earthquakes; the reasons for this link fracture are not currently clear and all 4 links will be the subject of detailed metallurgical and structural evaluations once they are removed.

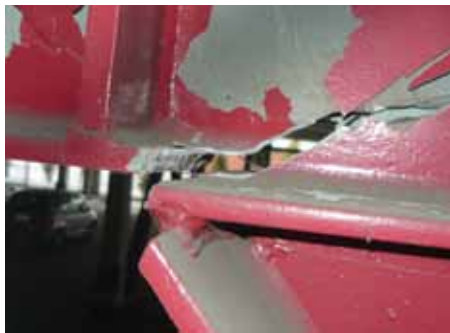
Fractures were also found in two bays of a low-rise parking garage having eccentrically braced frames (Figure 2). For a number of reasons explained elsewhere (Clifton et al.), this parking garage was not subjected to ground motions as severe as those felt elsewhere in Christchurch. However, because these EBFs were not drift dominated, they were designed for the maximum  $\mu = 4$  ductility demand. The cause of failure has been speculated to be due to an unintended offset observed between the brace flange and the link stiffener. As a consequence of this offset, the axial tension force in the brace fed into the active link/collector beam panel zone through a

flexible beam flange rather than directly into the stiffener, severely overloading this junction area, possibly leading to a fracture that spread across the beam flange and through the web. This suggests that load path through the as-constructed detail is particularly important when inelastic demand is required from the system. Note that at least six EBF frames were used at each level in each of the buildings' principal directions, and that this significant redundancy contributed to maintaining satisfactory seismic performance of the building in spite of those significant failures. Also, residual drifts of the parking structure or damage to the gravity load carrying system were not visually noticeable, which suggests that these fractures would have not have been discovered if hidden by non-structural finishes. As noted above, the fractured active links have been cut out and replaced to bring the building back into service.

Figure 2: Parking garage with fractured link at lower level EBF. Courtesy of Greg MacRae.
